EO 97165
January, 1998

Final Report

Town of Forest
Inflow/Infiltration Study

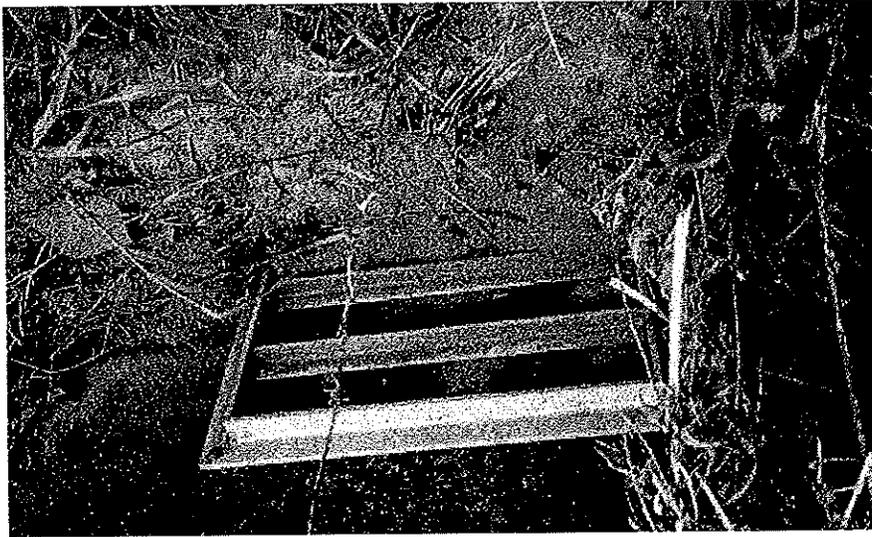
overflow still provides a level of protection against sewer surcharging, it is not required due to the installation of a back up power supply. The overflow pipe was found to be $\frac{3}{4}$ full of river sediment, indicating that the creek's hydraulic grade increases higher than the overflow pipe during some storm events. Consequently, water from the creek has entered the pump station, and is then pumped to the WWTP for treatment. This may be a significant source of short term inflow for a few storm events each year.

Picture 4.3.: Overflow Structure with Sediment

The pumping station overflow pipe that discharges to Hickory Creek has been identified as a problem location. It is recommended that a one way flap valve be installed on the overflow pipe to stop the back flow of water from the creek to the pumping station and treatment plant during large storm events.

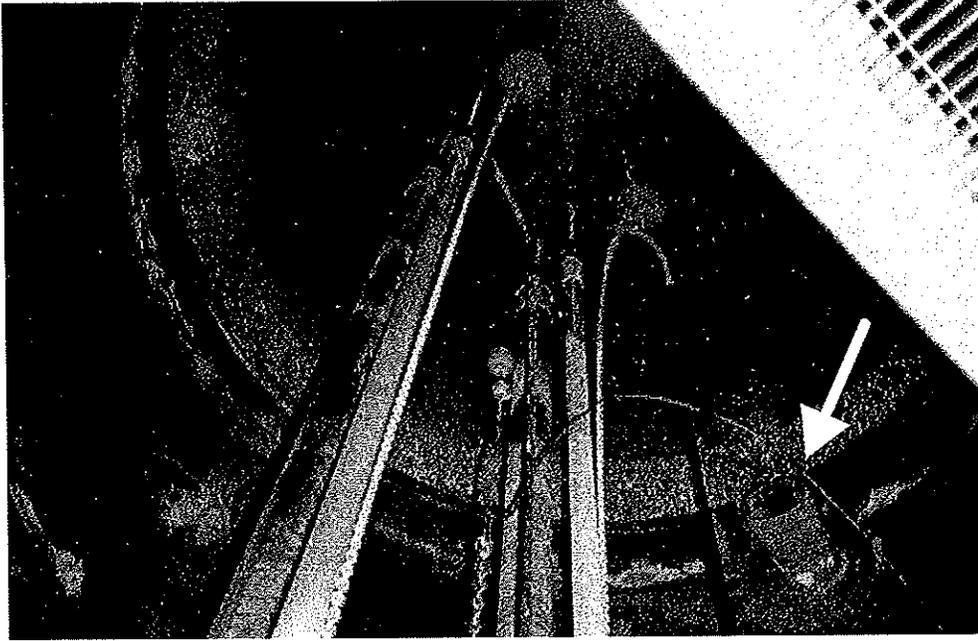
The wet well at the industrial park was visually inspected at various times throughout the study. It was found that a steady flow of water entered the wet well from a pipe in the north side of the well. The pipe leads from a vacant field to the north of the wet well. The exact reason for this constant flow of water into the well is not known. However, it is suspected to be the result of infiltration, since there are no buildings or services in the specific field.

Picture 4.5.: Industrial Park Wet Well showing Constant Inflow from Pipe

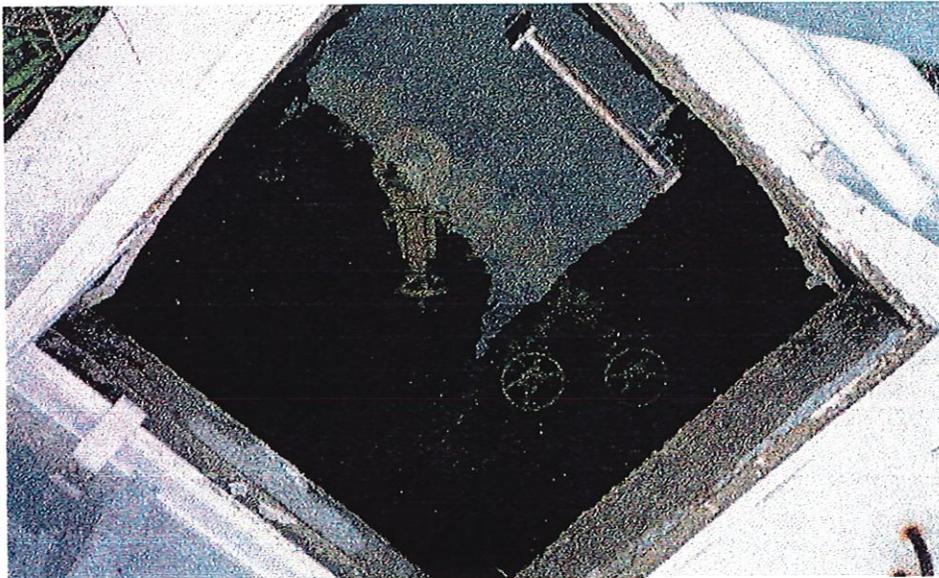
Inspection of the valve chamber at the wet well and pumping station revealed that the valve chamber was filled with ground water, indicating that the water table is high. Consequently, infiltration of ground water into all of the collection sewers in the industrial park likely occurs. It is recommended that the industrial park be inspected with a camera to access the condition of the pipes and joints in the park's sewers. This would allow for corrective measures to be taken if some deficient areas are located.

Picture 4.6.: Industrial Park Valve Chamber Filled with Water

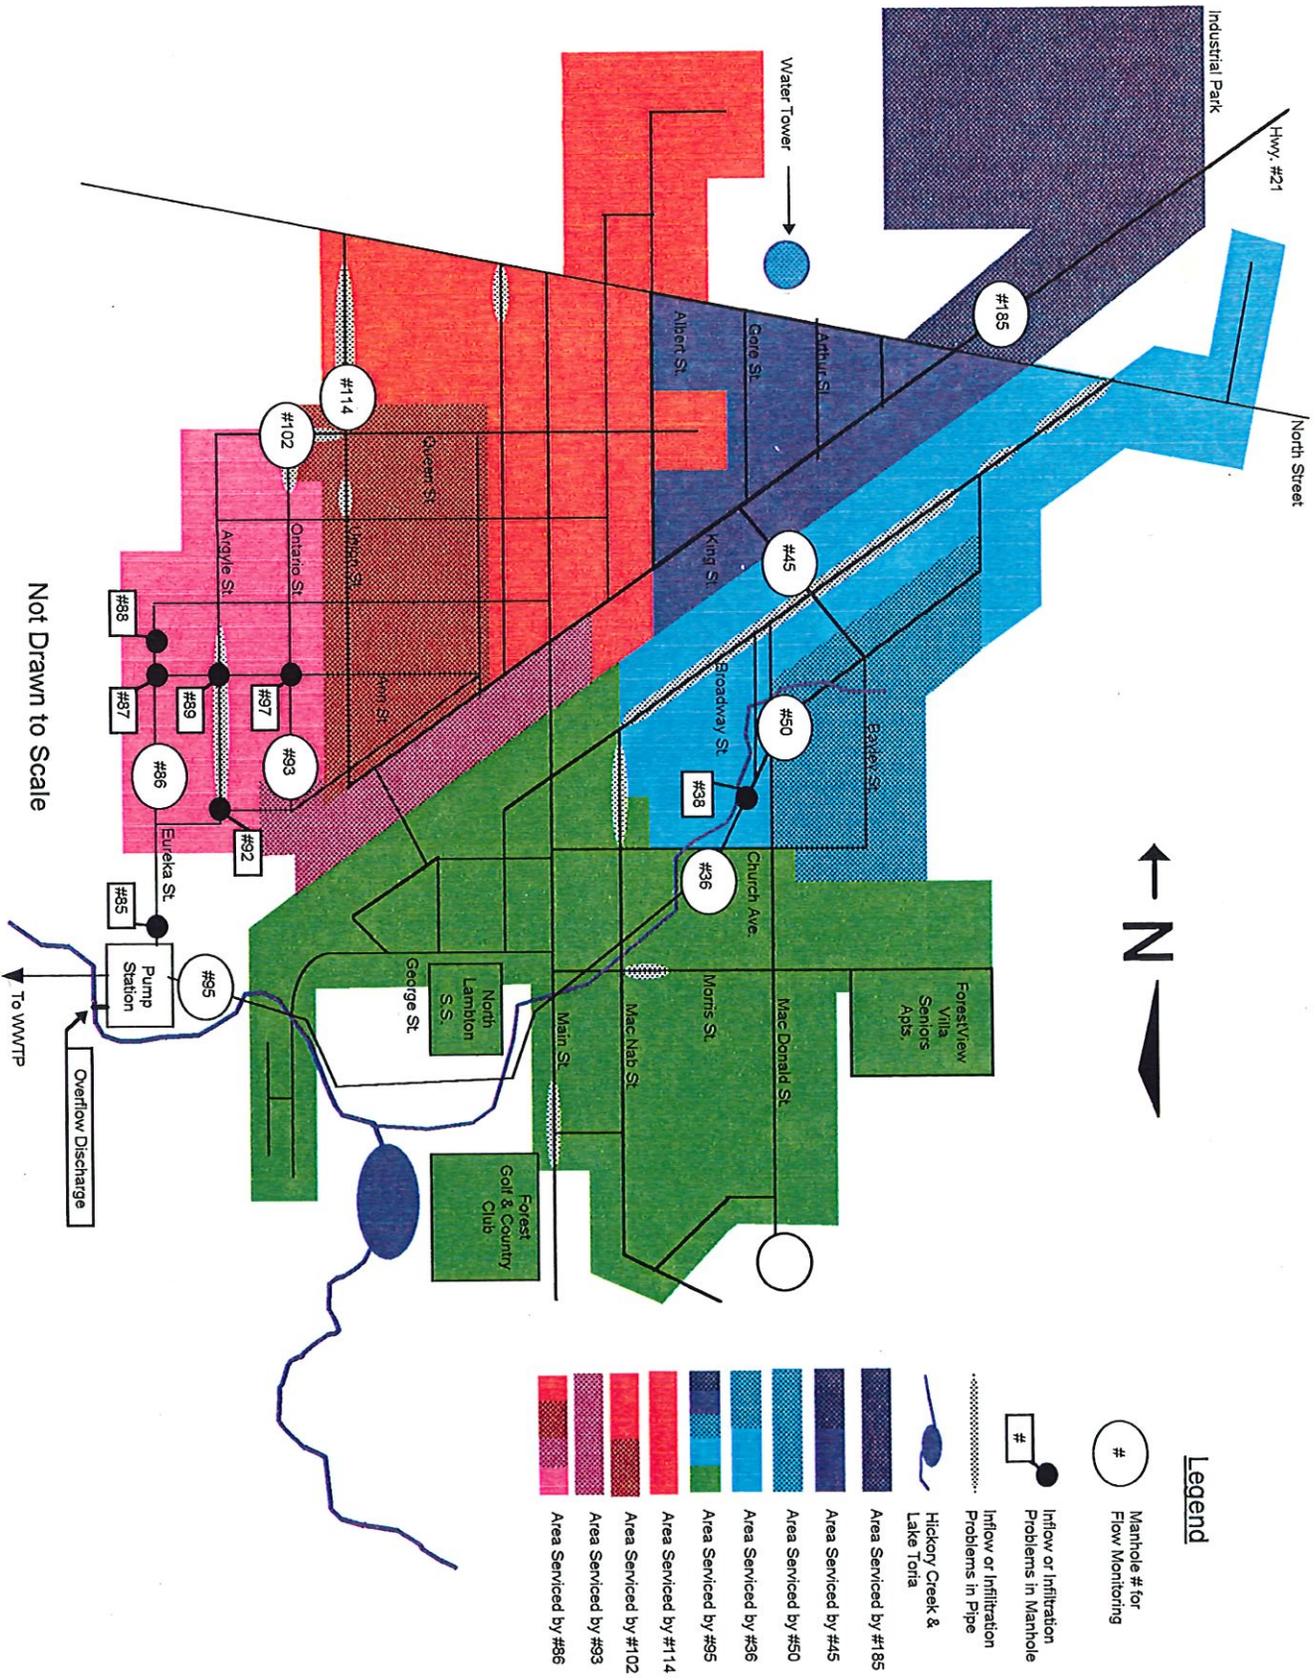
Figure 4.10.: Overview of Inflow and Infiltration in Town of Forest Sanitary Sewer System

The various colored areas represent sections of the Town that are serviced by the identified manholes. These manholes were used to install the flow meters for the hydraulic monitoring of this project. The manholes depicted as black dots indicate the location of manholes in the system that were inspected and found to be contributing to inflow and infiltration of water. The sections of sewer pipe depicted with long grey ellipses indicate sections of the system that were identified as contributing to infiltration from the review of the camera work.

downstream of manhole #45 has been shown to contribute to inflow and infiltration. A

large section of the sewer on Broadway St. has been shown to be in poor condition.
