## Summary Report:

Structure Name: BMROSS File #:  MTO #: Main Hwy / Road #: Bridge Condition Index (BCI):  10 CRV: \$549,000Road Name: Kinnaird Road

Inspection Date: 2025-10-28

Structure Location: 0.5 km South of Ipperwash Road/Ravenswood Line

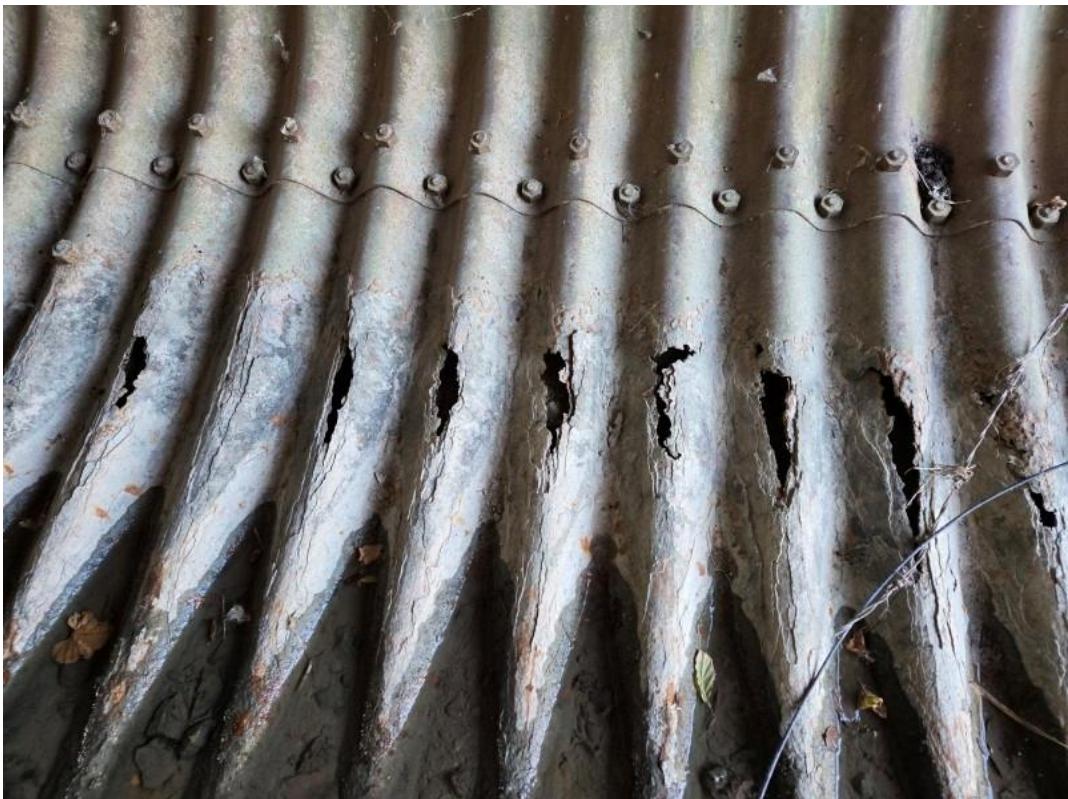
4 - Perforations at East End

Element:	Work Required	Period	Cost
Culverts	Replace structure	Within 1 yr.	\$400,000
<b>Repair/Rehabilitation Sub-Total:</b>			<b>\$400,000</b>

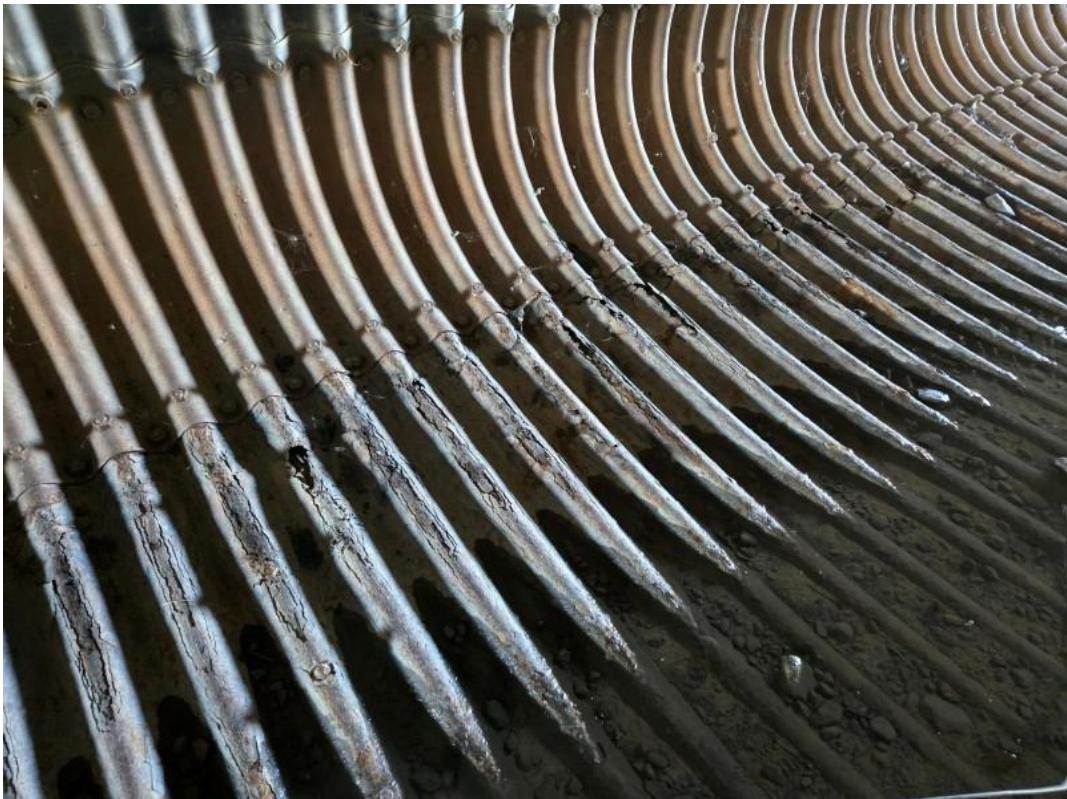
5 - Interior Perforations and Section Loss

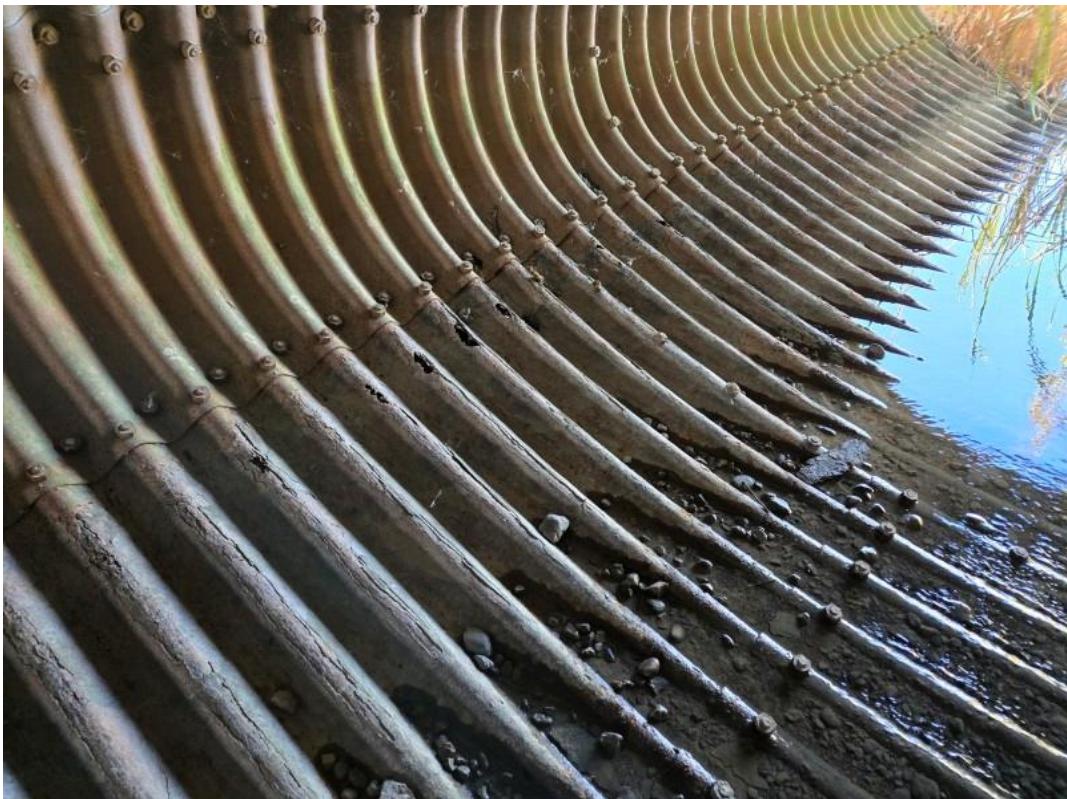
6 - Perforations at West End
