EO 97165
January, 1998

Final Report

Town of Forest
Inflow/Infiltration Study

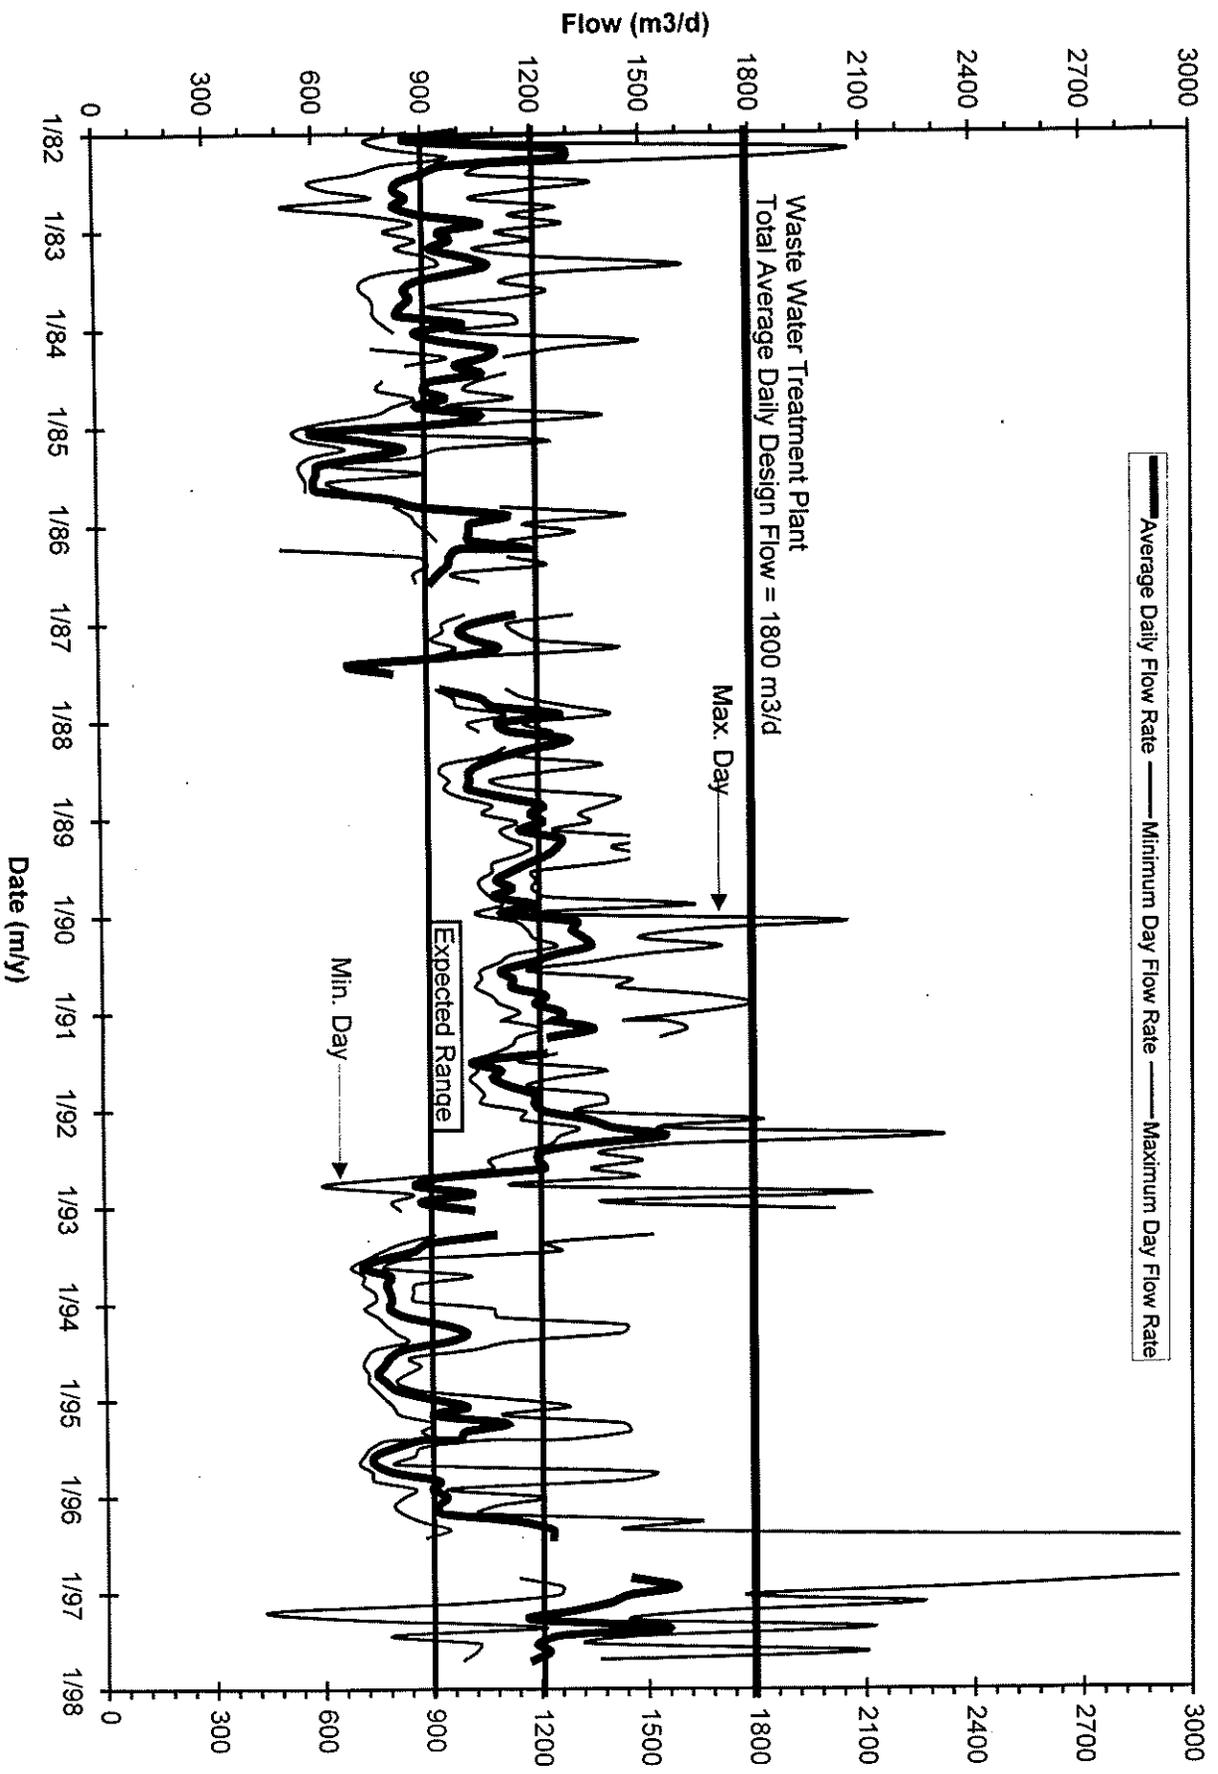
Figure 4.1.: Average, Maximum and Minimum Daily Flow Rates for Each Month at WWTP

The historic waste water generation rates for the Town of Forest was collected and analysed as outlined in Section 3.1. The entire set of historic flow data for the sanitary sewer system is provided in Appendix A. The average, maximum, and minimum day flow rates for each month from January 1982 to October 1997 are provided in Figure 4.1.

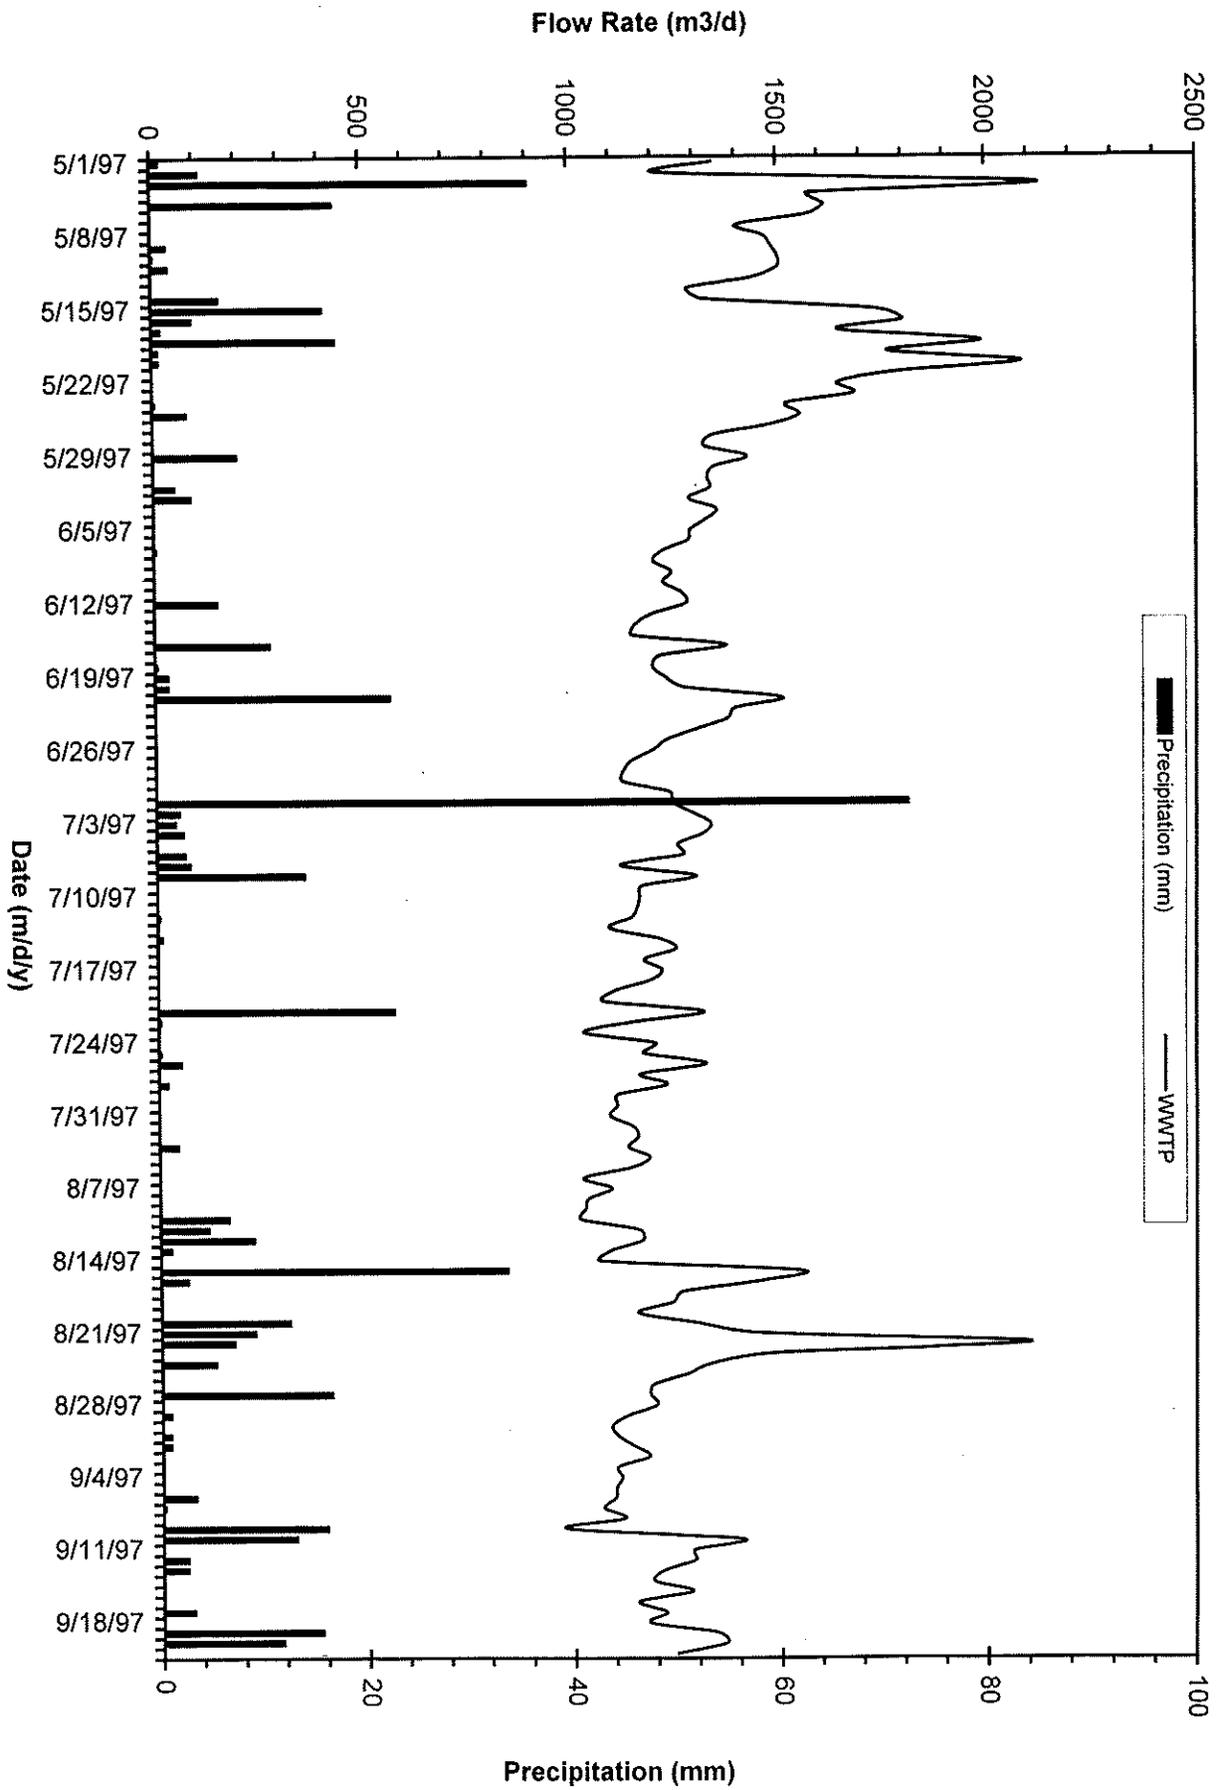
Figure 4.2.: Daily Waste Water Treatment Plant Flow Rates and Precipitation Events

The daily flow rates for the waste water treatment plant and the daily precipitation records from May 1, 1997 to September 21, 1997 are provided in Figure 4.2. The average flow rate was $1300 \text{ m}^3/\text{d}$ over this time period, with five days in excess of $1800 \text{ m}^3/\text{d}$. The flow rates at the waste water treatment plant increase above background levels for the majority of precipitation events. This indicates the existence

of inflow and infiltration problems since the sanitary system should not experience any significant increases in flow rates during a storm event.

The precipitation data indicates that the majority of storms recorded at Sarnia, impacted Forest's WWTP, since the plant's flow rates increased. However, the 72.4 mm event that occurred on June 1, 1997, did not increase the WWTP flow rates significantly. Consequently, the use of precipitation data collected at Sarnia as it relates to storms at Forest is not 100% accurate. Therefore, it is recommended that a rain gauge be installed at the Town of Forest Waste Water Treatment Plant to quantify the storm events at Forest, and correlate them with the plant flow rates. This would allow the plant operators to better quantify the effects of inflow and infiltration on the plant.

The WWTP flow rates typically peaked either on the same day or the day following the storm. Inflow of water into sanitary sewer system occurs instantaneously, while infiltration occurs over a longer duration with decreasing intensity. This indicates that the problem is likely not just an inflow problem which would result in an immediate increase in flow rates. Consequently, it is suspected that the Town's sanitary system is experiencing both inflow and infiltration.

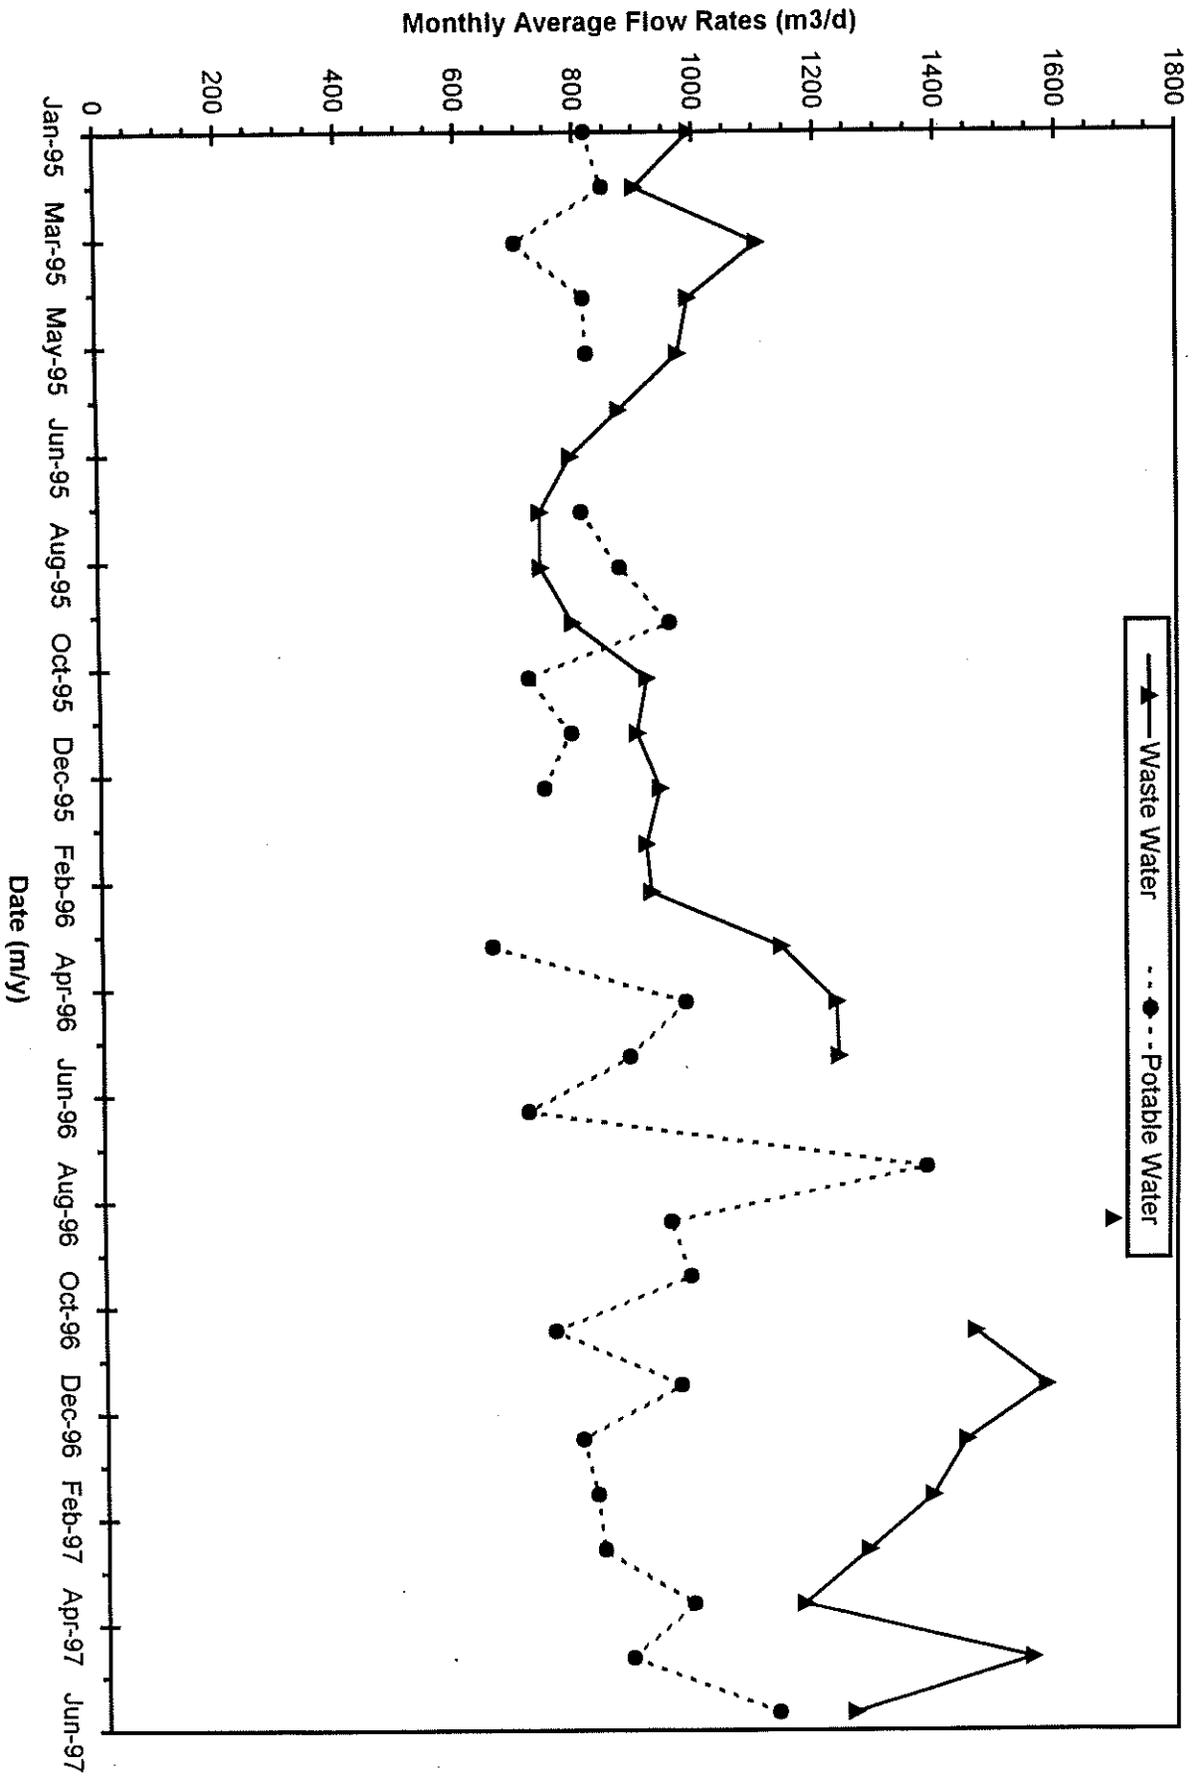
Figure 4.3.: Comparison of Waste Water Generation Rates and Potable Water Consumption Rates

The Town of Forest potable water usage rates were obtained from the Town of Forest as stated in Section 3.1. The monthly potable water volumes were compared to the waste water volumes, and are provided in Table 4.1, with a graphical representation provided in Figure 4.3.

It is clear that the volume of waste water being generated is significantly greater than the consumption of potable water. The difference in the volumes of water is likely caused by extraneous water entering the sanitary sewer system via inflow and infiltration. The volumes and rates of water as inflow and infiltration were estimated and are provided in Figure 4.4. The series of columns represent possible inflow/infiltration volumes assuming 15% consumptive water use. Viessman & Hammer (1993), indicate that a 15% loss from the distribution system and consumptive usage of potable water is accurate for most non-arid regions.

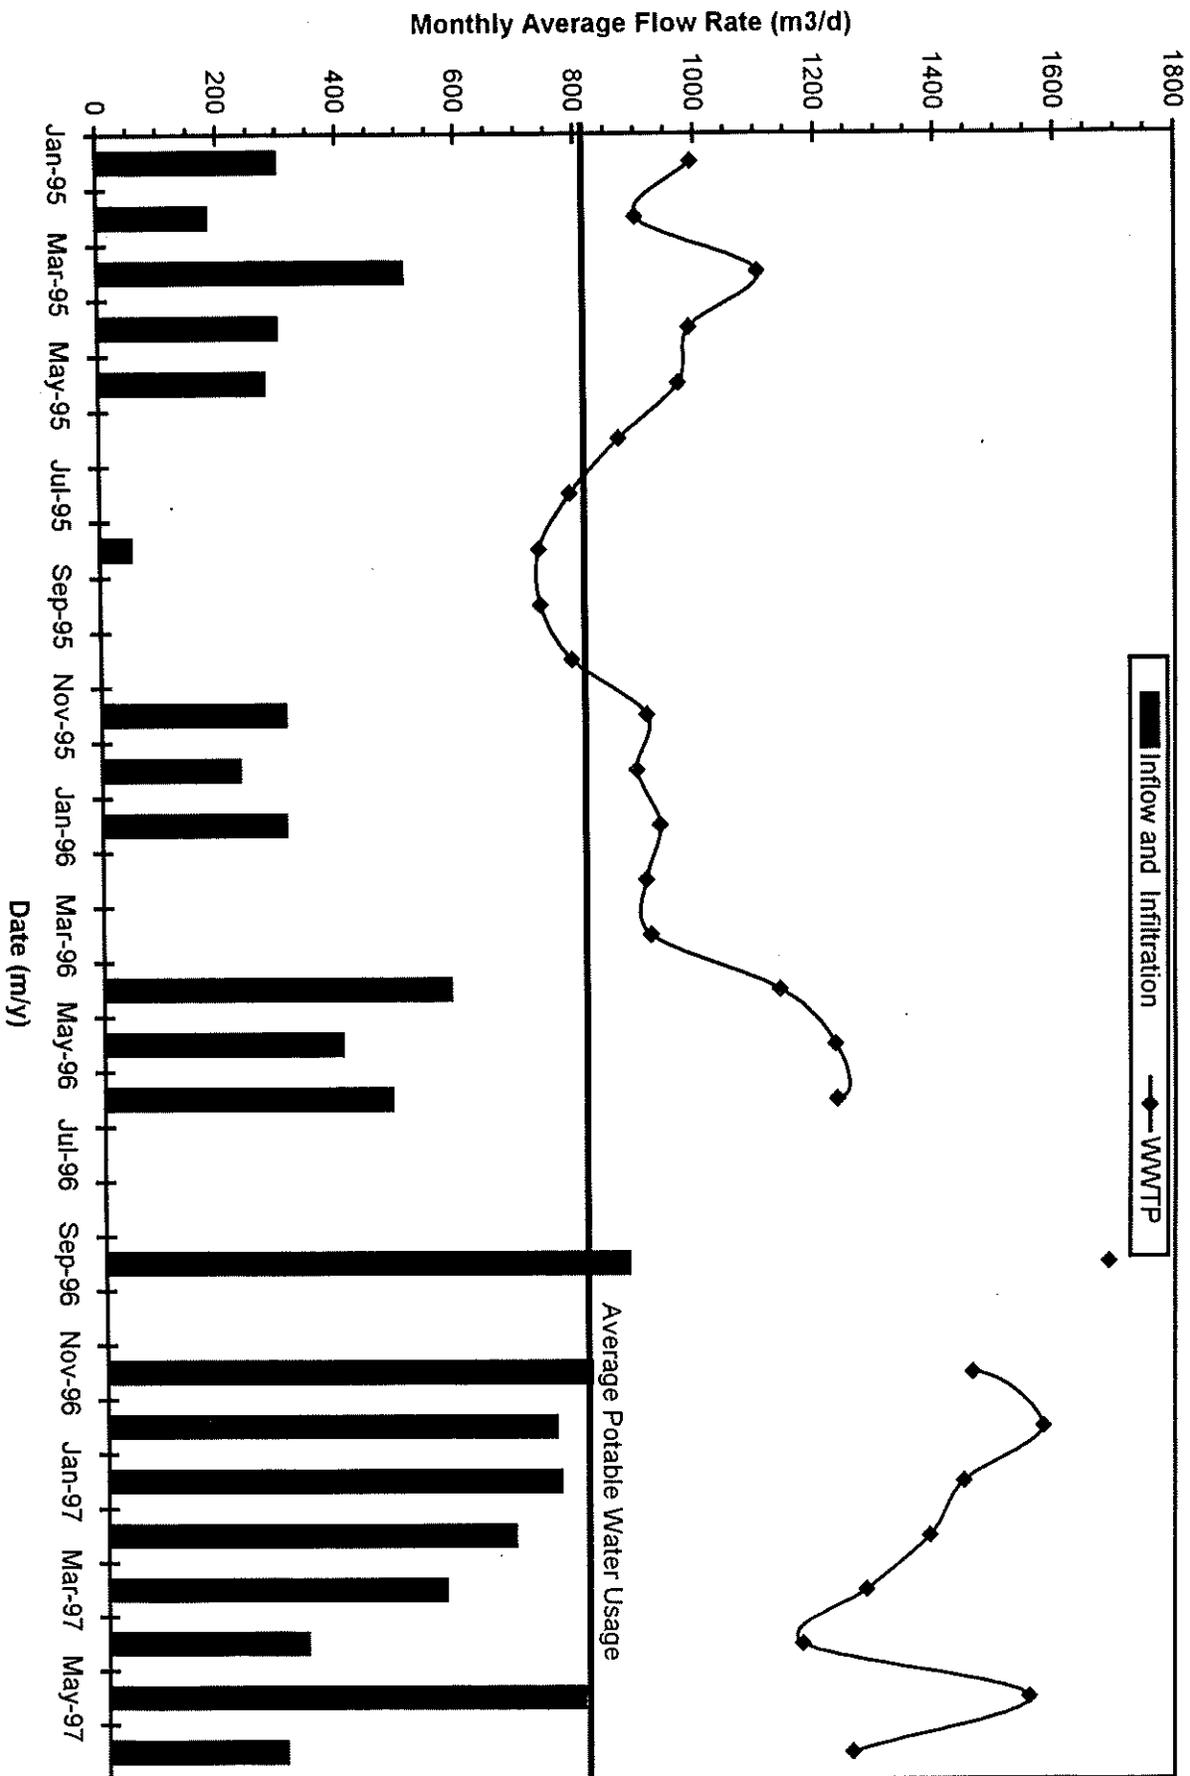
Figure 4.4.: Flow Rates of Water Entering the Sewer System Via Inflow and Infiltration

Inflow and infiltration volumes range from an average of 9,000 m³ to 19,000 m³ in a month. These volumes correspond to a range of flow rates from 300 m³/d to 630 m³/d on a continuous basis. However, it is estimated that volumes as high as 34,000 m³ in one month have been observed. Inflow and infiltration contribute on average 34%, with a range of 0% to 56% of the total waste water volume being treated by the WWTP.

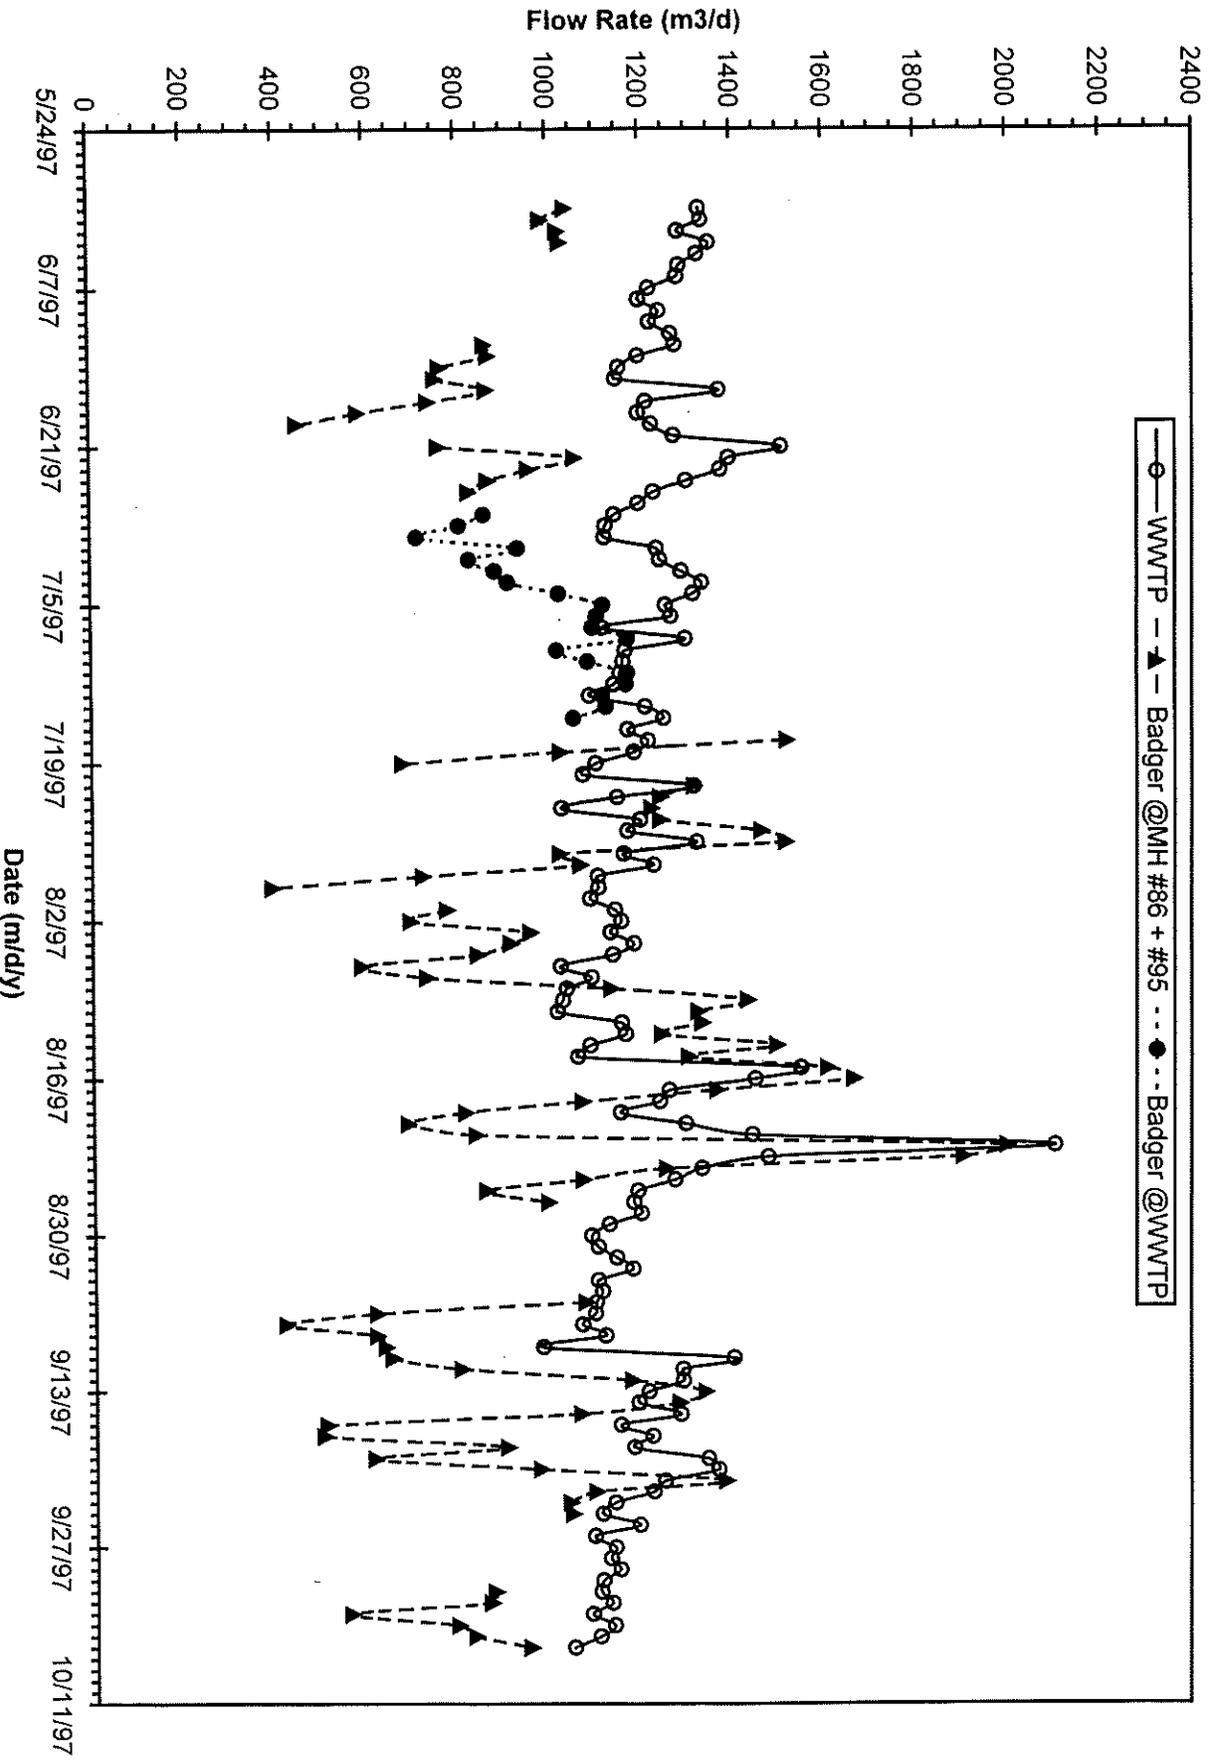
Figure 4.5.: Comparison of Flows Measured by Badger Meters to WWTP Flow Data

A flow meter was placed at the outfall of the WWTP (Site #6) to compare the flow data generated by the meter to the WWTP screen dump reports (i.e. flow data compiled from the plant's SCADA system) provided by OMI Inc. The meter was in place for 19 days from June 27 to July 15. Two flow meters were periodically placed at manholes #86 and #95 from May 31 to October 6, 1997. The entire volume of waste water generated by the town passes through both manholes prior to entering the pumping station. Consequently, the flow rates from these two manholes were combined and compared to the WWTP data. The data from the WWTP, flow rates recorded by the meter at the WWTP, and combined flow rates recorded by the meters at the manholes on Eureka Street (#86) and just east of the Clyde Street pumping station (#95) are provided in Figure 4.5. Figure 4.5 shows that initially (from May 31 to July 6) the data measured by the meters both at the WWTP, and the two manholes did not agree with the plant data (i.e. screen dump report). However, flow measurements were in reasonable agreement with the WWTP data, following this initial period.

The meter located at the WWTP was on average 17% different than the WWTP screen dump data over the period from July 7 to July 15, 1997. Flow rates obtained from the combination of flows at the two manholes, accounted for on average 90% of the WWTP flow. This indicates that the combination of flows at these two manholes is a good indication of sewer system flow rates. Further, all of these readings are within the suggested $\pm 20\%$ accuracy range for the flow meters.

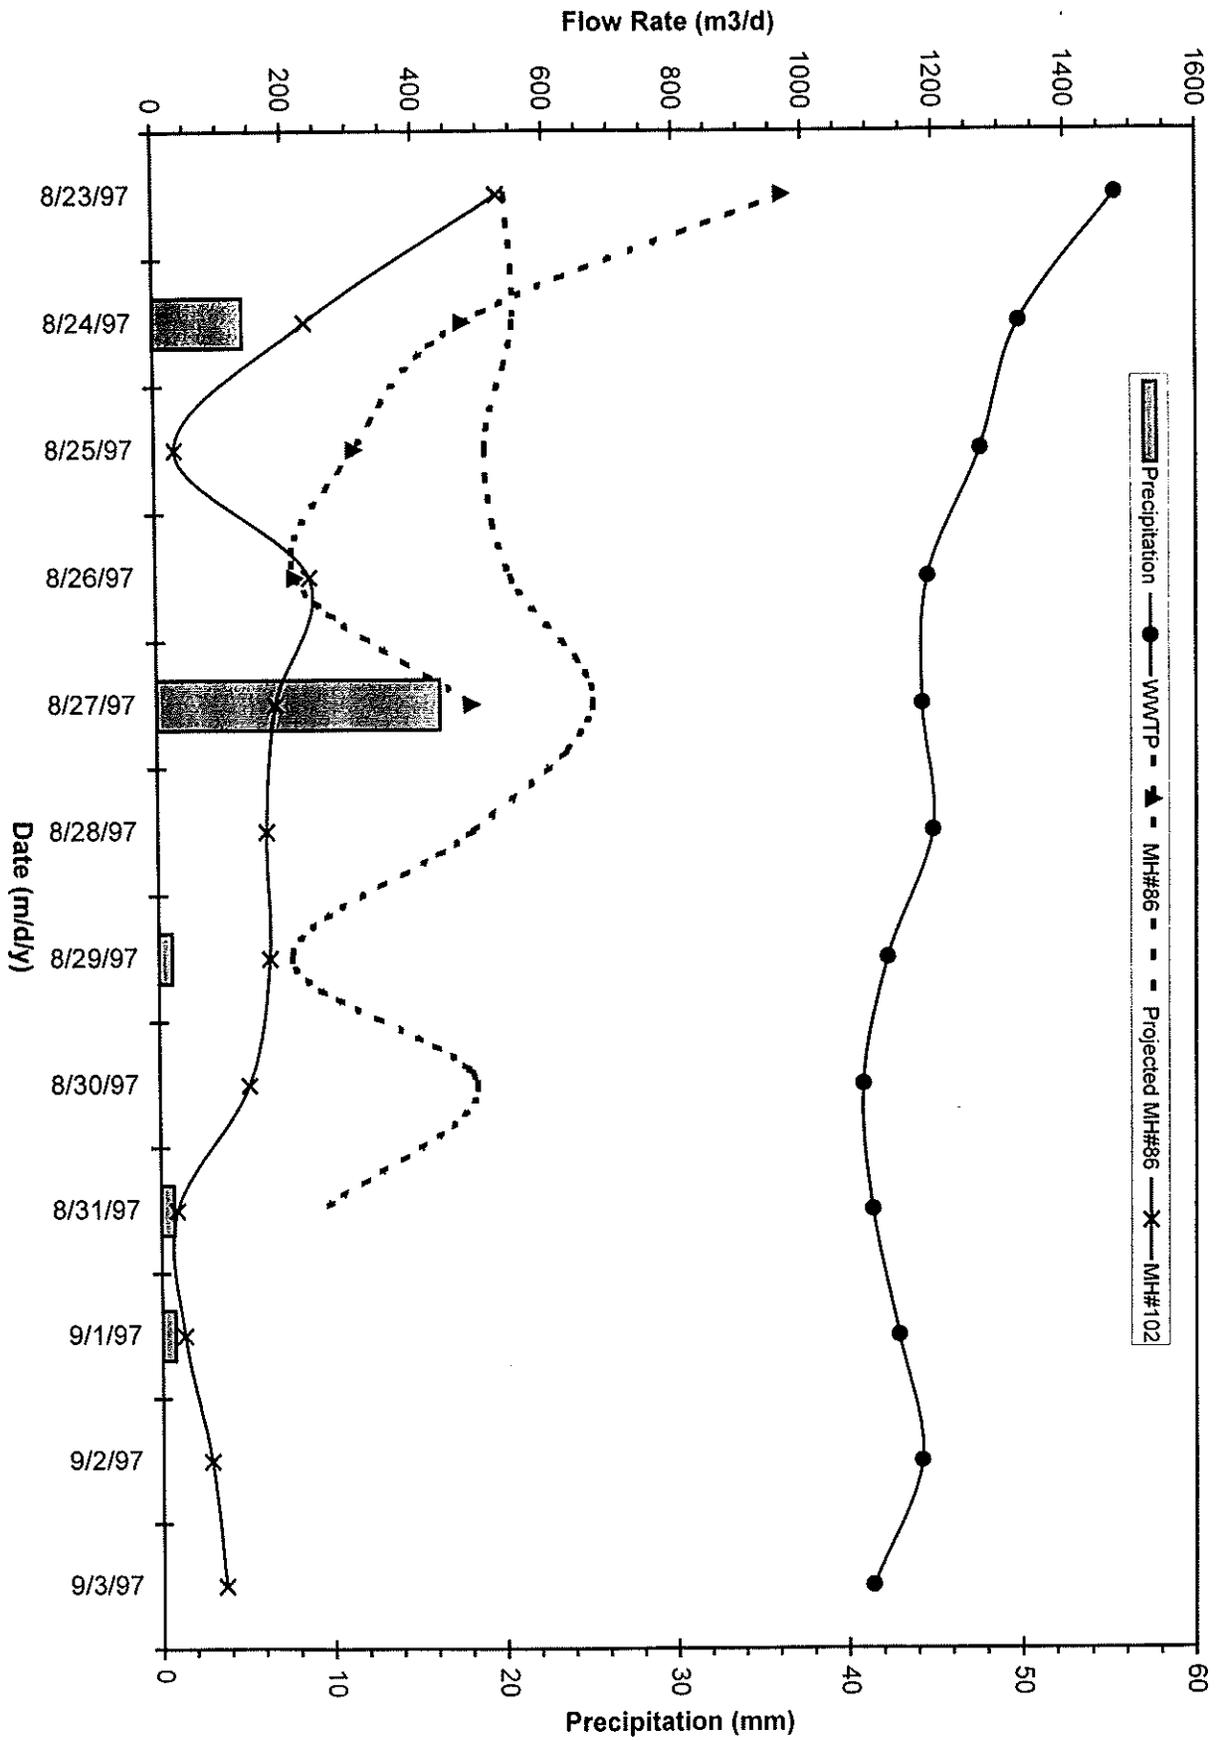
Figure 4.6.: Contribution of Flow at MH #102 to Flows at MH #86

A flow meter was located in the manhole at the intersection of Queen Street and Ontario Street (#102) for the period of August 23 to September 3, 1997. The flow data recorded for manhole #102, manhole #86, and the WWTP, as well as precipitation data for the period are provided in Figure 4.6. There were 5 storm events, 3 insignificant events, and 2 small (6 & 14 mm) events during this time. The WWTP flows declined from 1450 m³/d to 1100 m³/d over the period. The flow rates at manhole #102 were measured over the entire study period. The meter located at manhole #86 collected data for the first 5 days of this study period prior to the batteries going dead. The projected data for manhole #86 was calculated by subtracting the flow rates measured at manhole #95 from the WWTP data. This provides some understanding of the flows rates at #86, since the combined flow of the two meters have been shown to be comparable to the WWTP data. The flow rates measured at manhole #86 were larger than the flow rates measured at manhole #102, with the exception of August 26, 1997. It is expected that flows at #86 would be larger than at #102 since it is downstream of #102. However, manhole #102 on average accounts for 40% of the flow at manhole #86. Consequently, 60% of the water flowing through manhole #86 is being introduced into the sewer downstream of #102. Based upon the size of the service areas for these manholes, it is estimated that between 50 and 300 m³/d of extraneous flow is entering the sewer system between these two manholes.

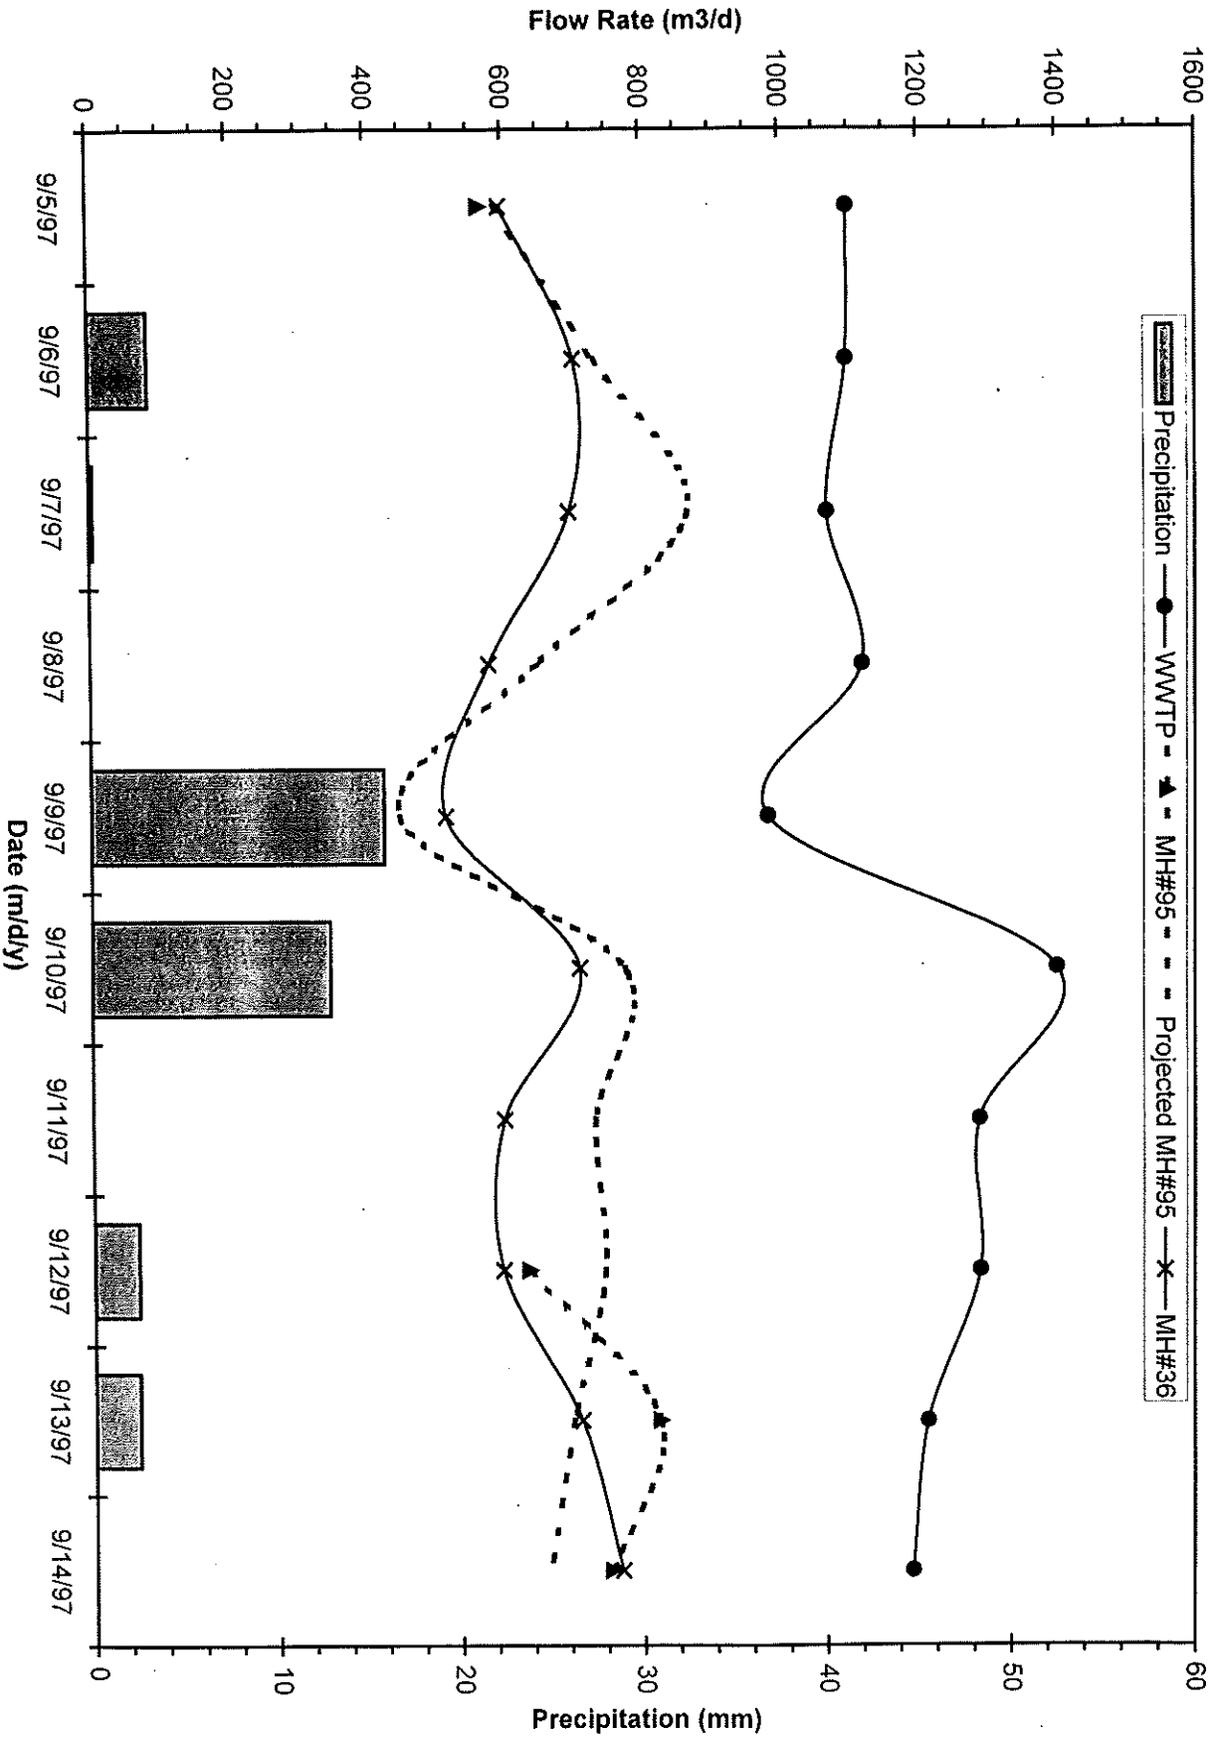
Figure 4.7.: Contributions of Flow at MH #36 to Flows at MH #95

The flow rates at both manholes #36 & #95 were approximately 650 m³/d over the entire period. The flow rates at manhole #36 were on average 95% of the flows at manhole #95. The service areas for manhole #36 is approximately half of the service area for manhole #95. Consequently, it was expected that the flow rates at manhole #36 would be approximately half of the flow at manhole #95. Therefore, inflow and infiltration of water is suspected to be occurring upstream of manhole #36.

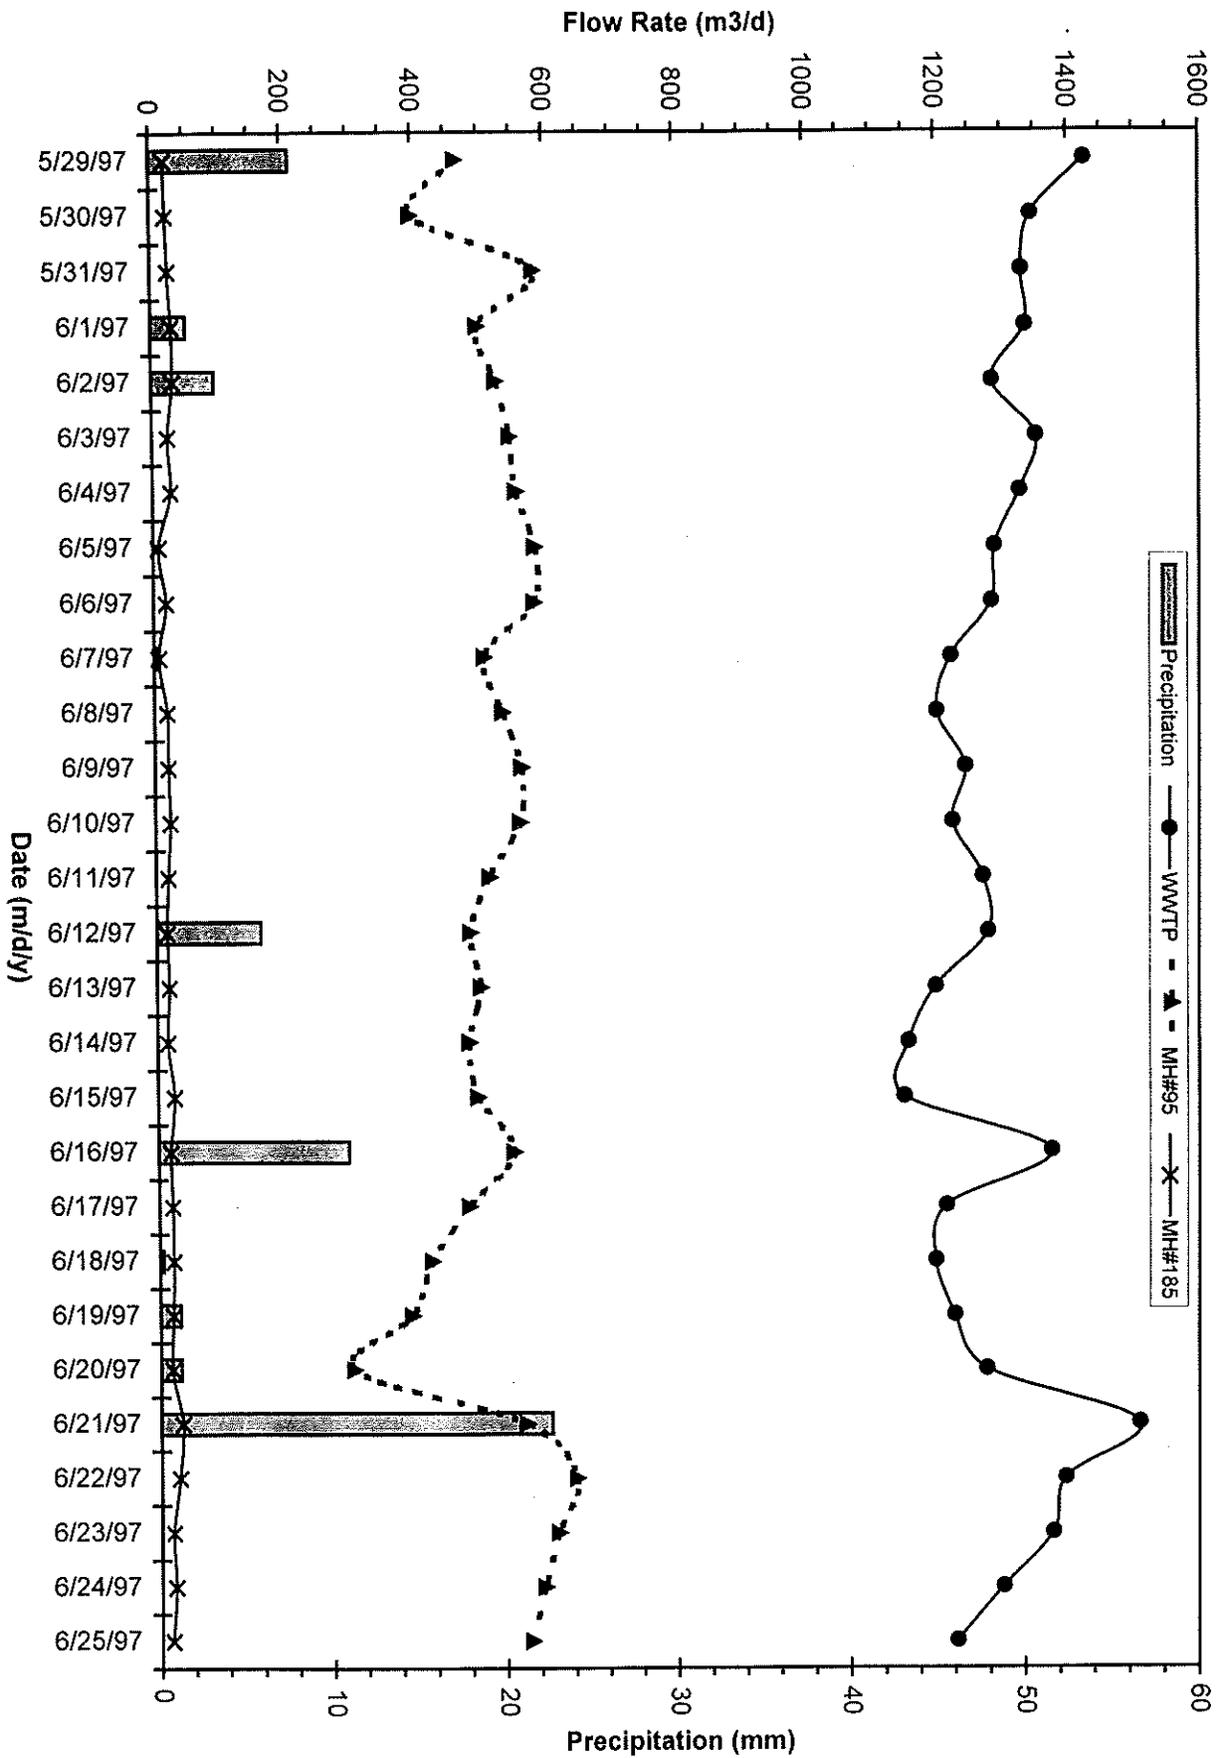
Figure 4.8.: Contribution of Flows at MH #185 to Flows at MH #95

A flow meter was installed at manhole #185 for the period of June 29 to July 25, 1997 to isolate the flows from the industrial park force main. The precipitation data, and the flow rates from the WWTP, manhole #95, and manhole #85 are provided in Figure 4.8.

The flow rates at the WWTP and manhole #95 increased due to the precipitation events on June 16 and 21 respectively. However, flow rates from the industrial park measured at manhole #185 maintained steady rates regardless of precipitation events. The waste water generated at the industrial park is collected in a wet well and periodically pumped via a force main into the sewer system upstream of manhole #185. Pump data provided by OMI Inc. indicates that the total run time for the

pumps at the pumping station was 0.6 hours over the entire 28 day study period. This translates into approximately 8 m³/d of flow from the wet well (based on a pump rate of 100L/s). The data indicates that the industrial park contributes insignificant flows to the sanitary system. However, the visual inspection has found that the structural integrity of the industrial park force main is in question. Therefore, some uncertainty exists as to the effectiveness of the force main at delivering all of the water collected in the wet well into the gravity sewer system.

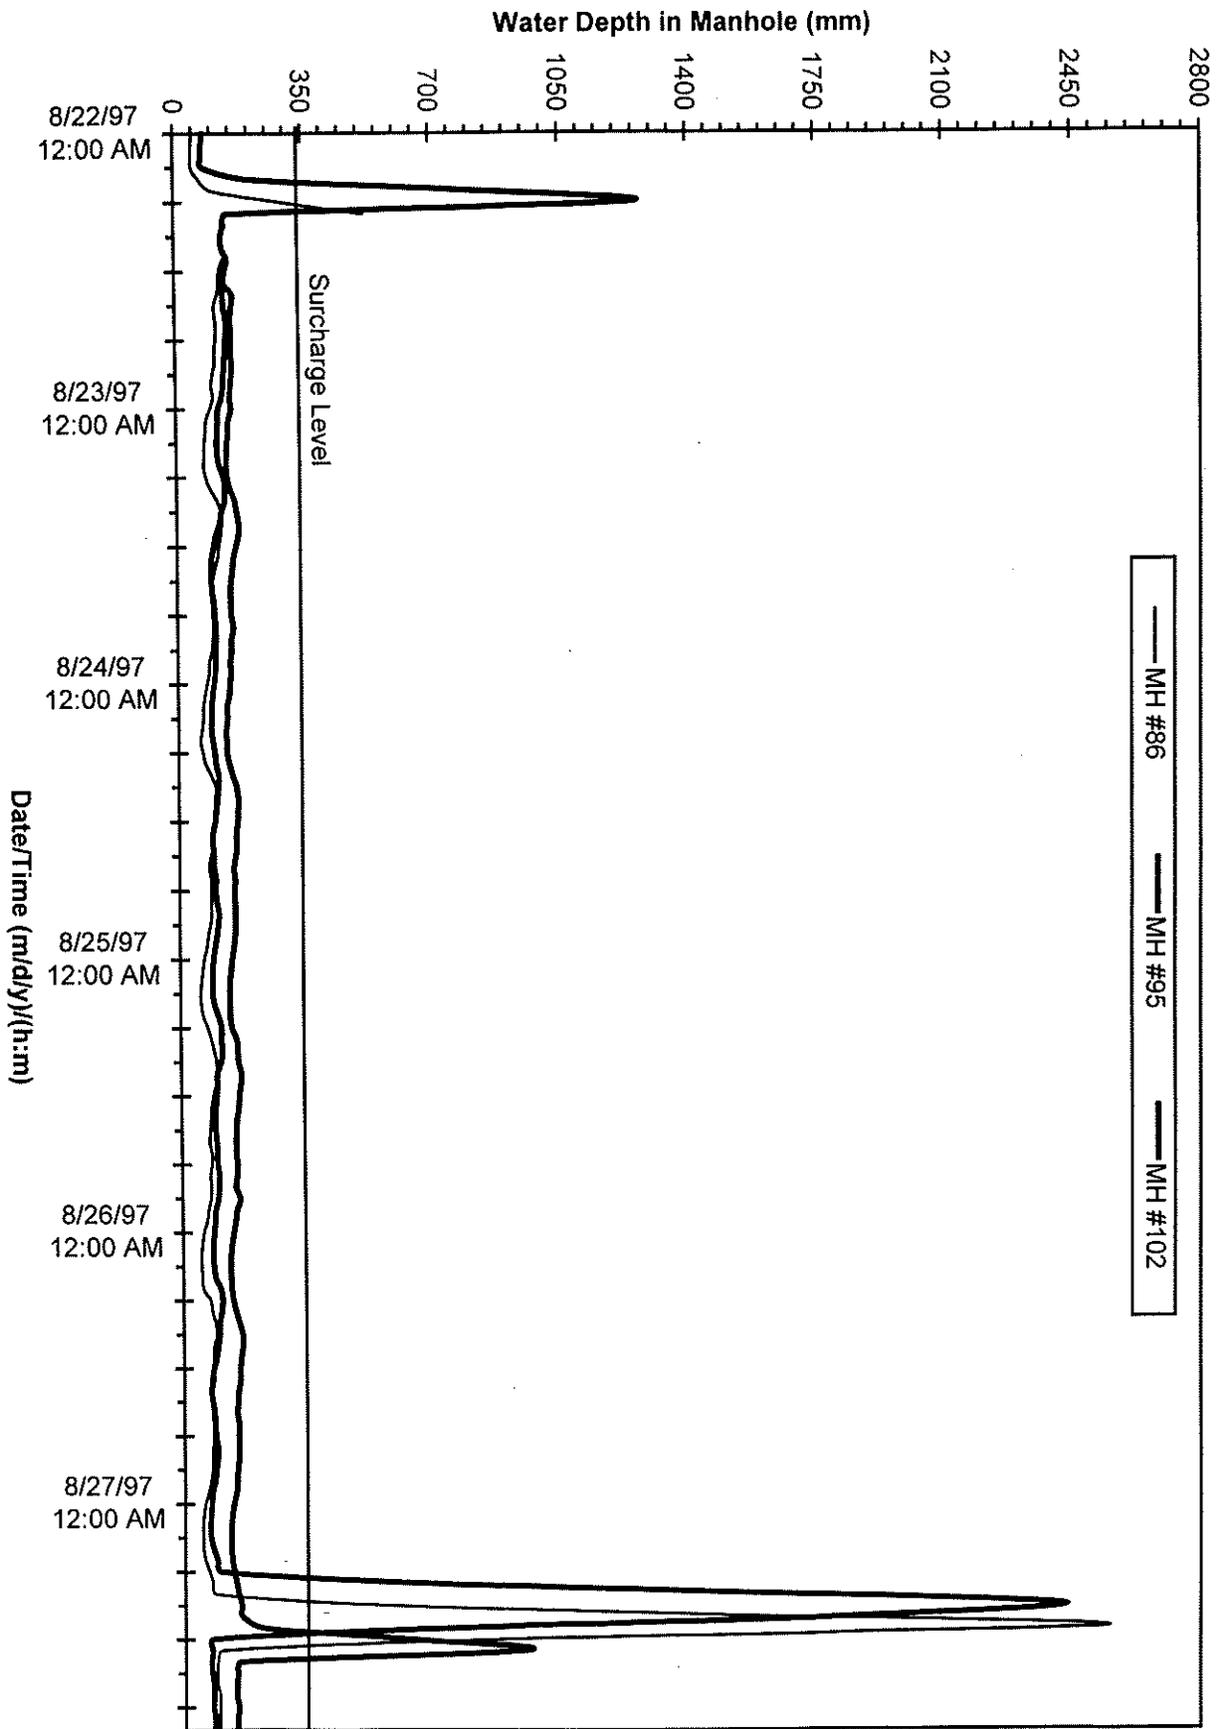
Figure 4.9.: Surcharging in the Town of Forest Sewer System

Hydraulic monitoring has uncovered that on two occasions during this study, portions of the sewer system have surcharged. The downstream portion of the system was surcharged on August 22, and August 27, 1997. The depth of water in manholes #86, #95 and #102 recorded by the flow meters are provided in Figure 4.9.

On August 27, 1997 the sewer system surcharged again. The pipe upstream of manhole #95 became surcharged at 6:00 AM and reached a peak height of 2.5 m above the sewer invert. The pipe upstream of manhole #86 surcharged at 8:00 AM and reached a maximum peak of 2.5 m above the invert. Manhole #102 was also surcharged starting at 11:00 AM and reached a maximum height of 1 m above the invert.

The fact that the pipes (i.e. manholes) became surcharged in the order shown in the figure indicates that the water likely entered the sewer system from Hickory Creek. Subsequent to a phone conversation with OMI Inc., it was determined that precipitation events at Forest for both of these days were very intense in the morning. During the field visit by Proctor & Redfern Limited staff on September 4, 1997, the flow meter located in manhole #95 was no longer supported by the ladder rung, but was hanging down in the manhole by the safety strap. This indicates that the surcharge event actually occurred and that the levels in the manhole reached near to the top of the manhole and floated the monitor off of the ladder rung.
