## Summary Report:

Structure Name: BMROSS File #:  MTO #: Main Hwy / Road #: Bridge Condition Index (BCI):  10 CRV: \$549,000Road Name: Kinnaird Road

Inspection Date: 2025-10-28

Structure Location: 0.5 km South of Ipperwash Road/Ravenswood Line

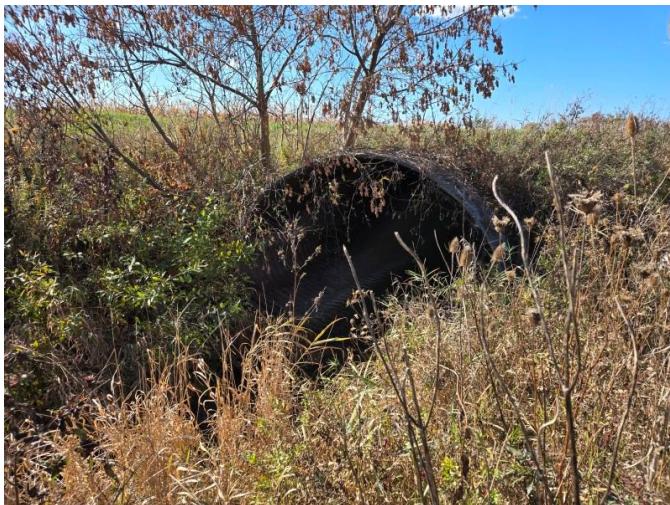
2 - East Elevation

Condition Summary: Replacement recommended  Recommended Timing: Within 1 Year Current Load Limit: N/A Overall Comments: Structure is in poor condition. Replacement is recommended within 1 year.

Element:	Work Required	Period	Cost
Culverts	Replace structure	Within 1 yr.	\$400,000
Various	Associated Work		\$189,000
		Total	\$589,000
